All Saints, Shillington – Application for the removal of trees in the churchyard

Ref: 222350-1124G

Further Information

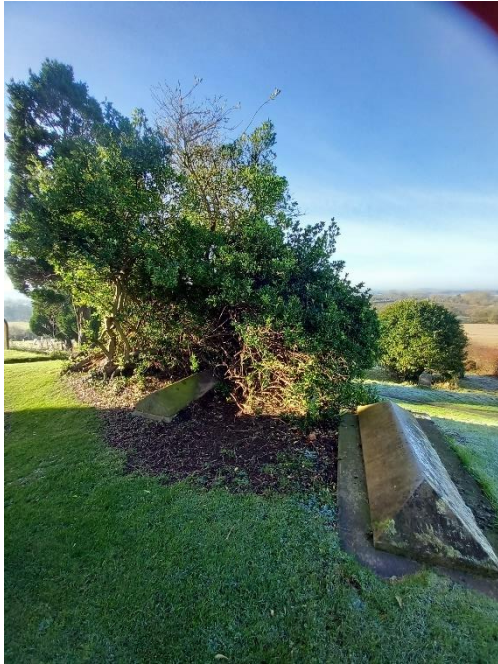
Of the six remaining trees in the Upper Avenue, the two middle trees were blown down in the storm of February 2022. This now leaves 4 cypress trees, plus a large bush at the top by the tower in the middle of which is a spindly dead tree, probably a self-set wild damson or similar (attachment 1 and 3).

Avenue bush at the top (1)

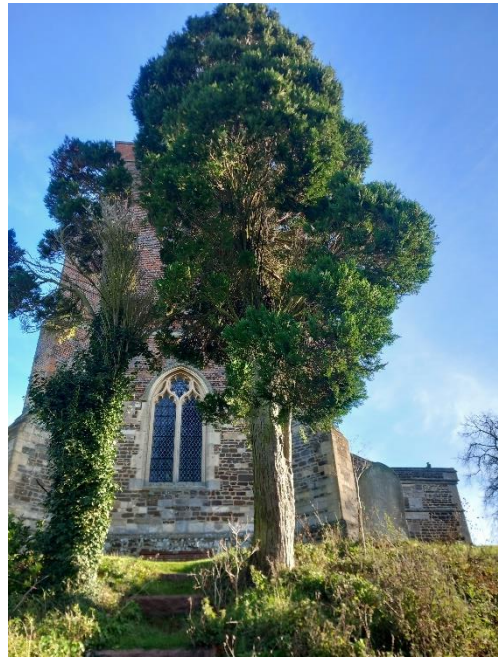
The photos attached show in greater detail the state of the remaining trees. The two nearest the path (photos 2, 4 and 5)) appear to be the remains of the original trees where branches have rooted themselves into the ground following the failure of the main trunk. At the top of the steps, looking towards the tower from the path, the left-hand side tree is almost dead (photo 1). The only tree in any reasonable state is the one top right looking from the path.

Avenue Trees, top left and right from below (2)

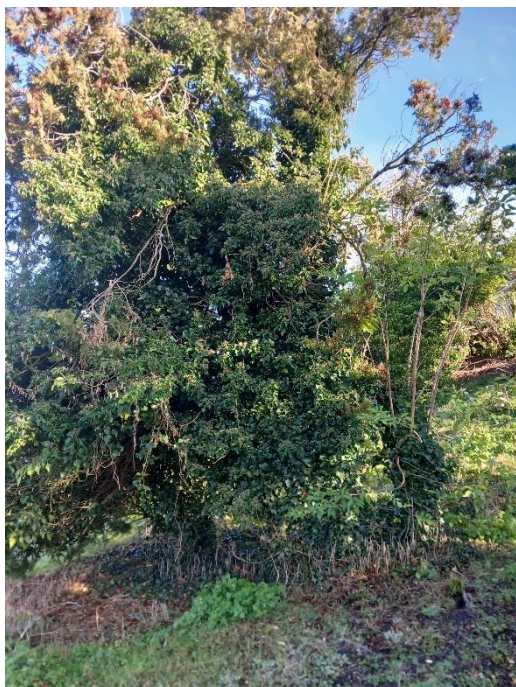
Bottom left tree (3)

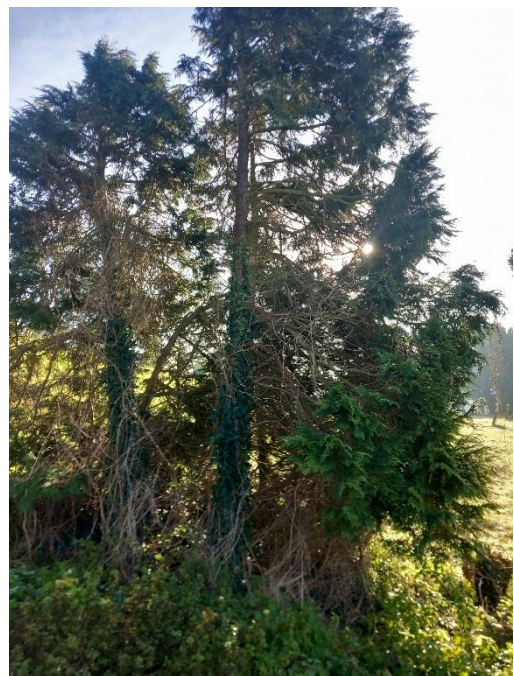
Bottom left tree from steps at the side (4)

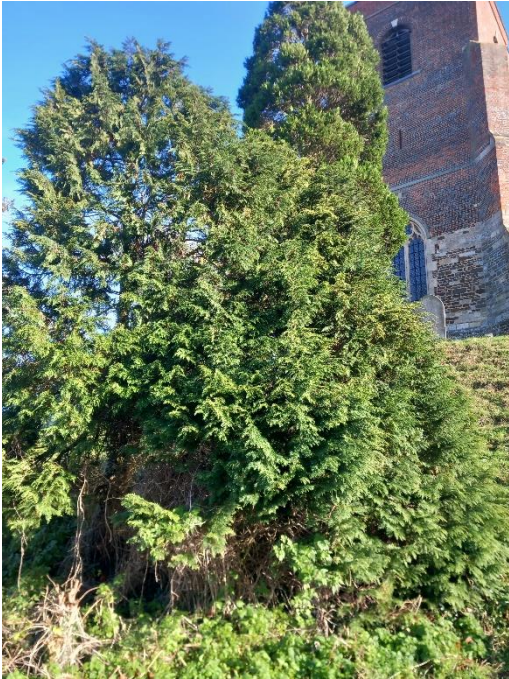
Bottom right tree looking up (5)

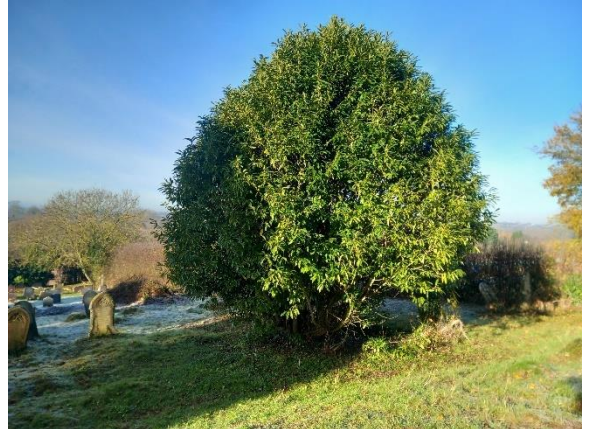
The laurel tree in the lower part of the churchyard (the north west area) is either self set or was planted on a grave many years ago. (Photo 6). This area of the churchyard was previously very neglected and is still the most difficult to care for. The tree has grown largely unchecked and is now smothering a number of graves. It is in the wrong place and is too big. Laurels are not native to this country and are largely used as hedging.’

Laurel tree (6)
